REFURBISHMENT PROTECTIVE COATINGS FOR CONCRETE

SUSTAINABLE REFURBISHMENT OF COOLING TOWERS

KEY STAGES IN THE CONCRETE REFURBISHMENT PROCESS

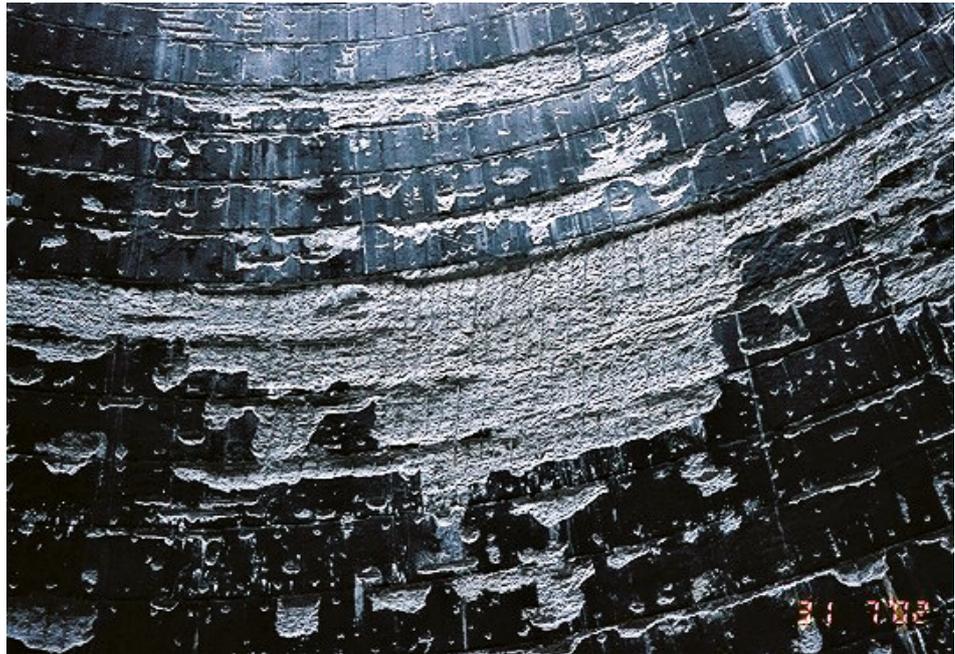
Severe deterioration of concrete and corrosion of reinforcing steel despite a previously applied inadequate coating in the internal face of a cooling tower.

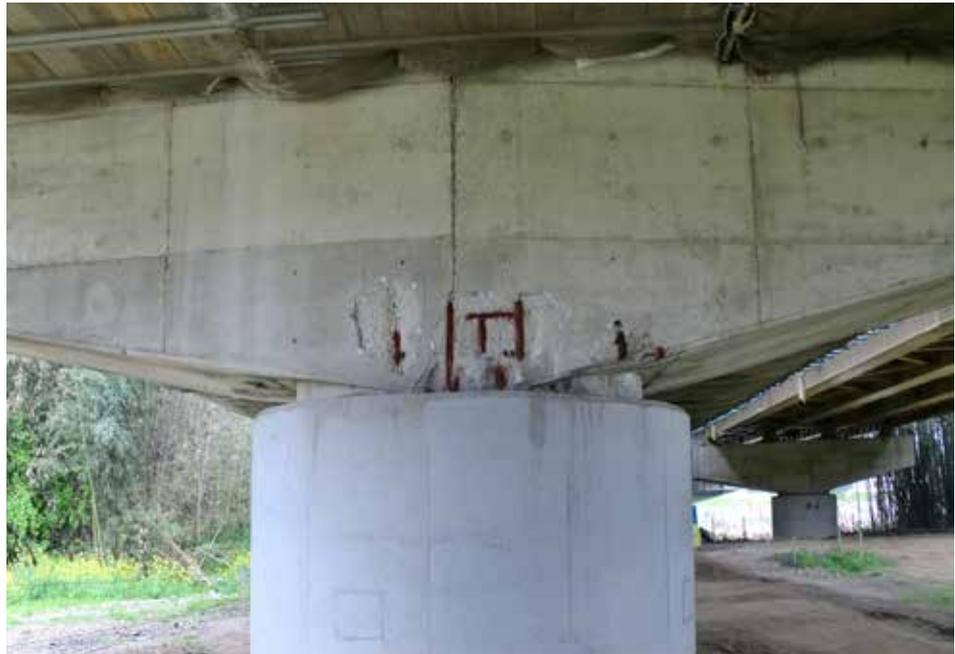
General corrosion induced by carbonation aggravated with low concrete cover issue.

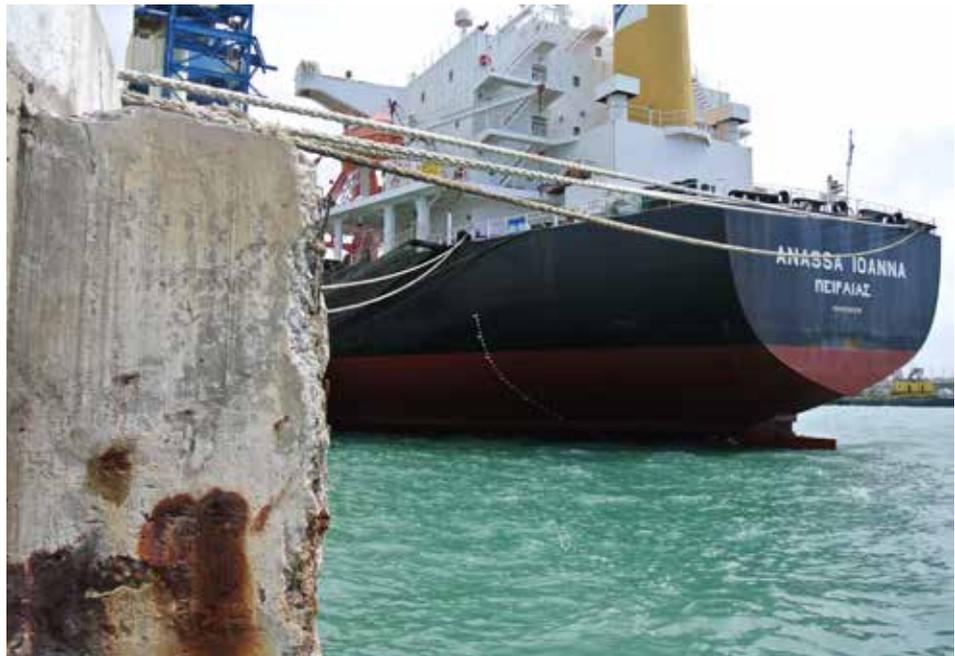
Reinforcing steel corrosion in a pier.

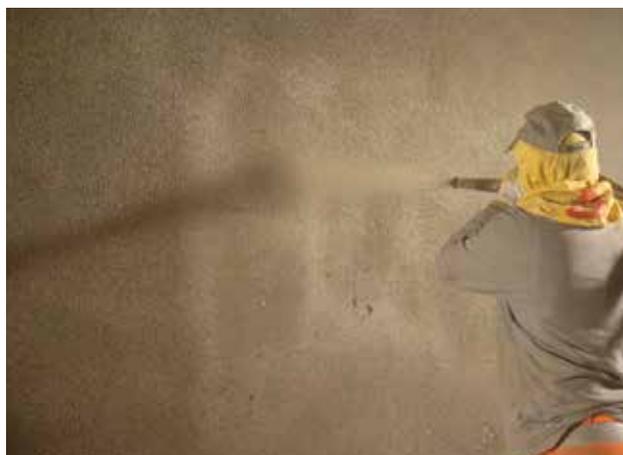
Sika MonoTop®-723 N: resurfacing mortar for hand and spray application.
